WORLD COAL[®]

AUGUST 2018 - VOLUME 27 NUMBER 7

CHAINS: THE PRIORITY

Kazimierz Hanuszkiewicz, Capital Group FASING Plc, Poland, discusses how the adjustment of mechanical properties can increase the durability and lifetime of a plow chain in extreme performance conditions.

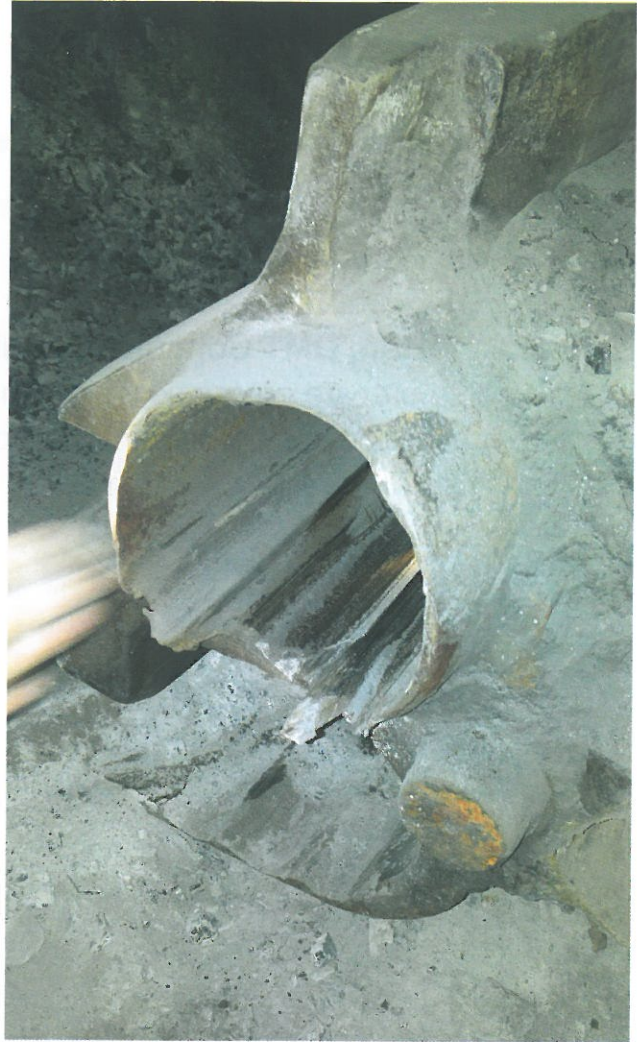
Figure 4. Damaged guide duct.

In addition, if chain guide ducts are not aligned, conveyor plates may get damaged as well. The degree of duct wear may be observed by comparing the as-new duct condition with the damaged guide duct.
